Fault Zone – Rotor

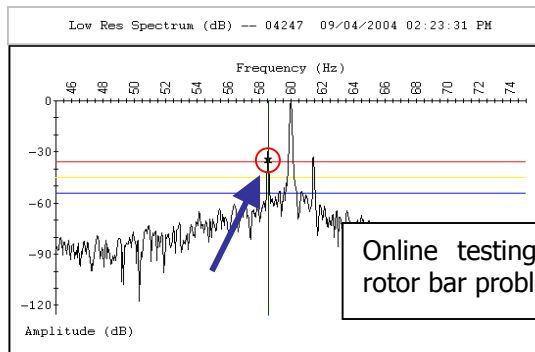
Online testing results indicate a severe rotor bar problem at 60% FLA.

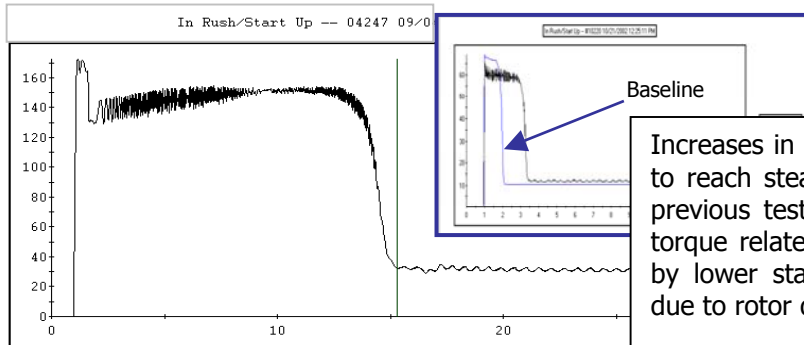
Increases in the start-up time required to reach steady state as compared to previous tests are a result of load or torque related issues and are affected by lower start-up current and torque due to rotor defects or lower voltage.
